MILESTONE INSPECTION – PHASE I REPORT

Gulfstream Towers Association, Inc.
33 S. Gulfstream Avenue
Sarasota, Sarasota County, Florida 34236

SOCOTEC Project Number VS231486

May 2024

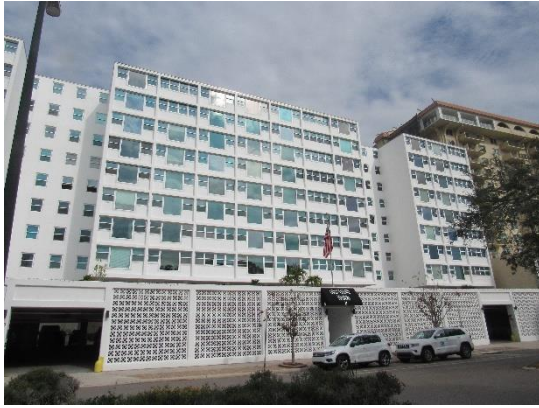
Partial view of the front of the building.

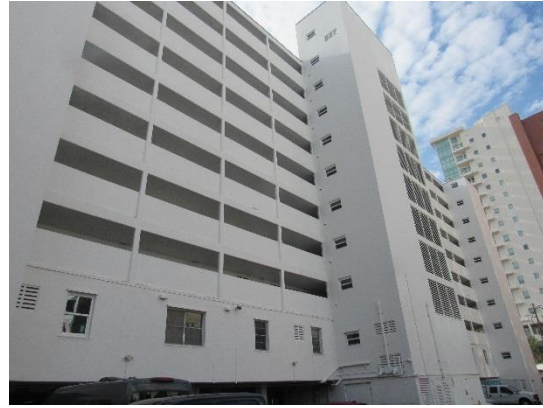
Partial view of the rear of the building.

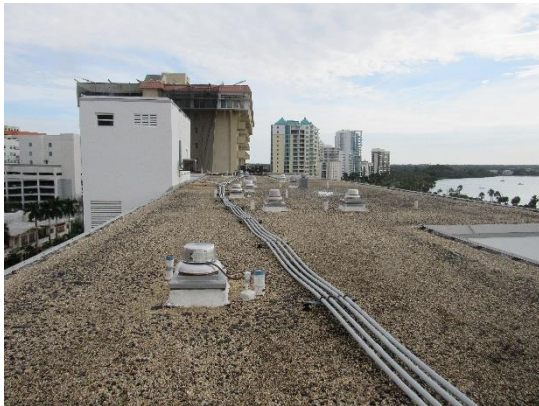
Typical view of the roof.

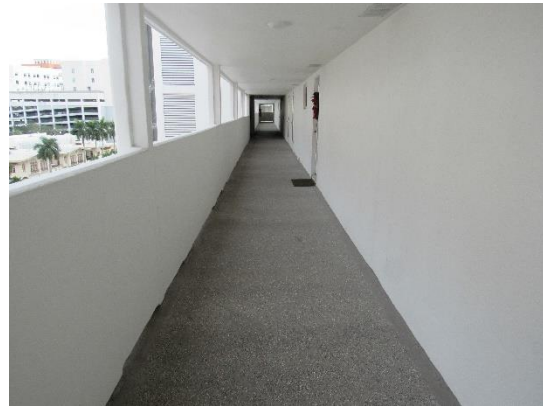
Typical view of the breezeways.

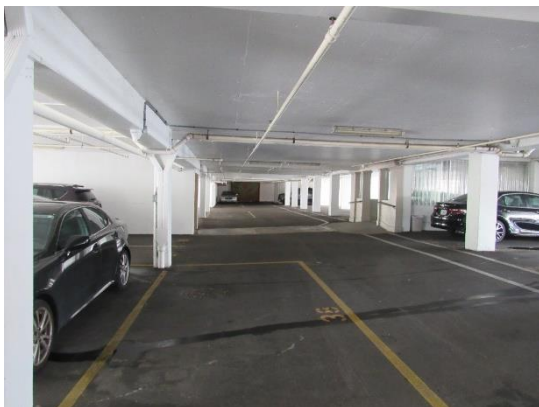
Typical view of the parking garage.

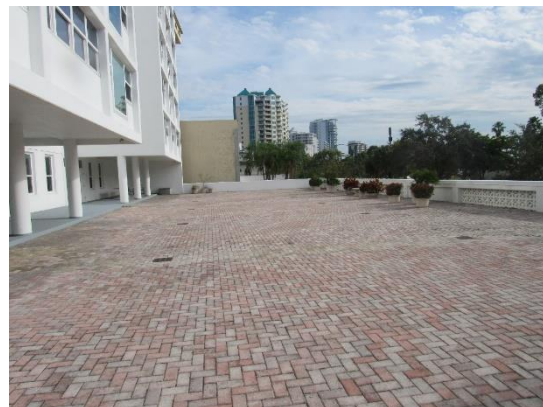
Typical view of the pool deck.
