Report of Structural Integrity Reserve Study

**GULFSTREAM TOWERS ASSOCIATION, INC.**

33 South Gulfstream Avenue  
Sarasota, Sarasota County, Florida 34236

SOCOTEC Project Number VS231486  
March 2025

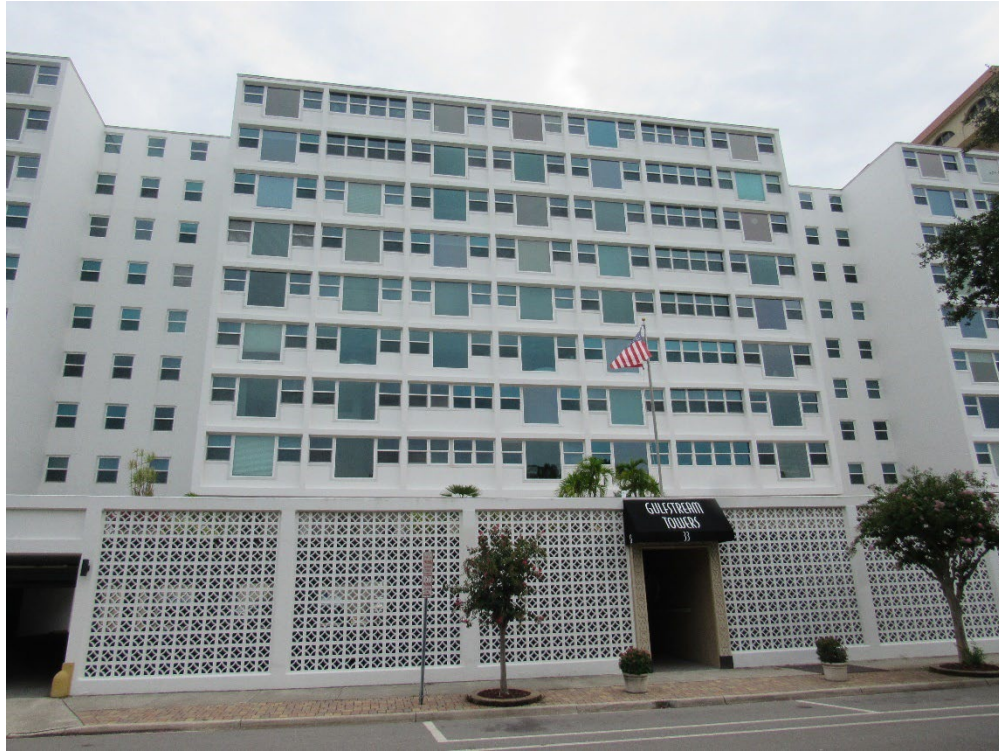
Partial view of the front of Gulfstream Towers.

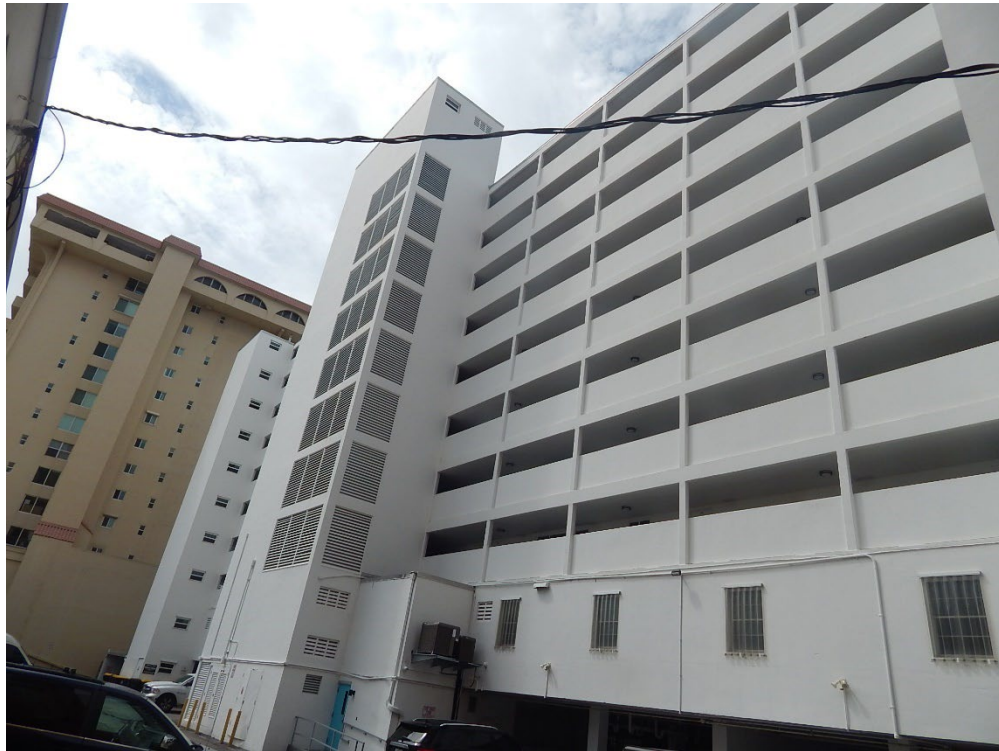
Partial view of the back of Gulfstream Towers.

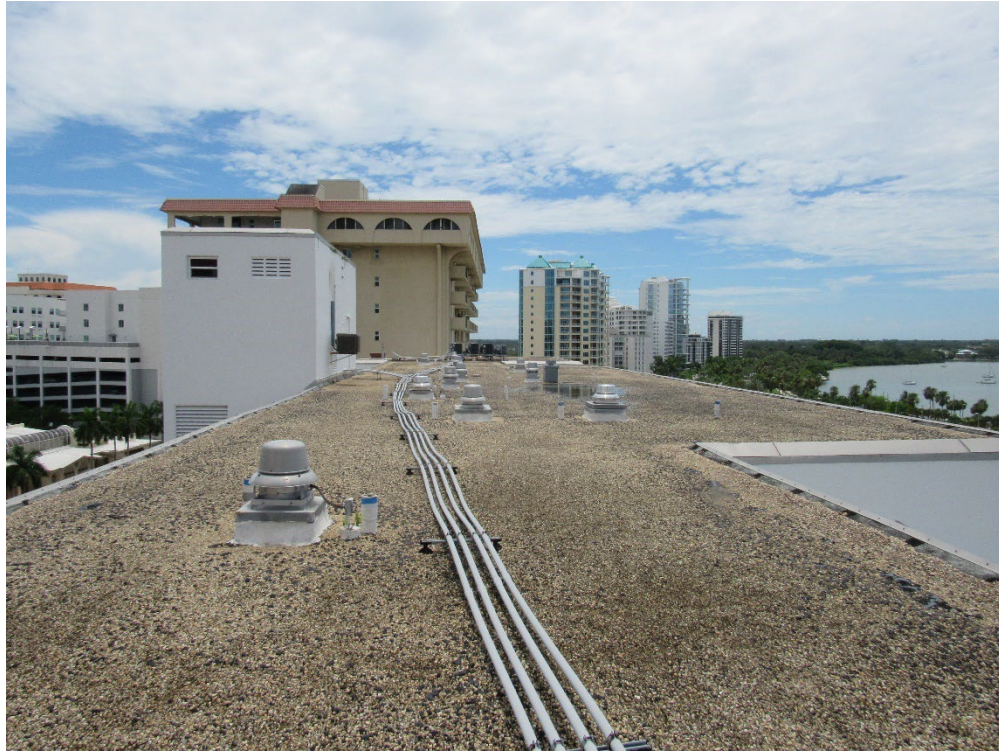
Coal Tar Pitch Roof – The low-sloped roof consists of a coal tar pitch built-up roof system with embedded gravel. Coal tar pitch roof systems have been known to have a useful life of 30 years or more with normal upkeep and maintenance. The coal tar pitch roof was observed to be in good to fair condition at the time of our site visit, with no reported active leaks. Furthermore, we understand the association is planning on replacing the roof in 2025.

Partial view of the Coal Tar Pitch roof system.

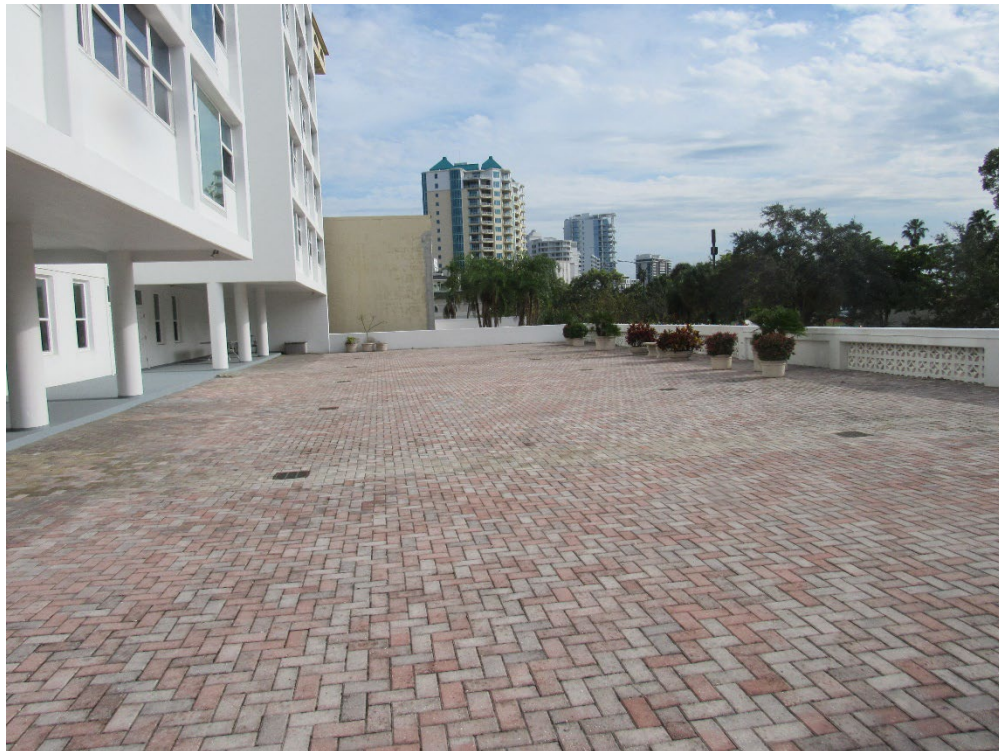
Waterproofing – We understand that the Association is responsible for maintaining and recoating the breezeways and pool deck. Typical waterproofing systems have useful lives of 10 to 15 years dependent upon the system and exposure. Exterior horizontal concrete decks should be

waterproofed to protect the concrete structure from deterioration. A reserve has been included for replacement of the breezeway waterproofing and the pool deck waterproofing.

Typical view of the pool deck.

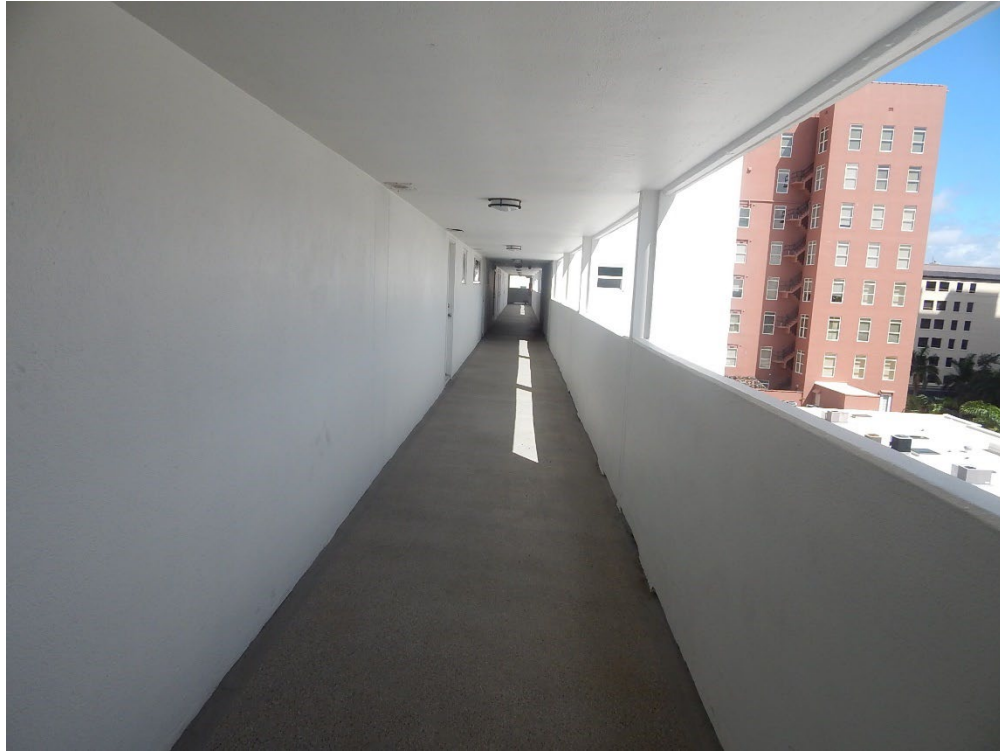
Typical view of the exterior breezeway.

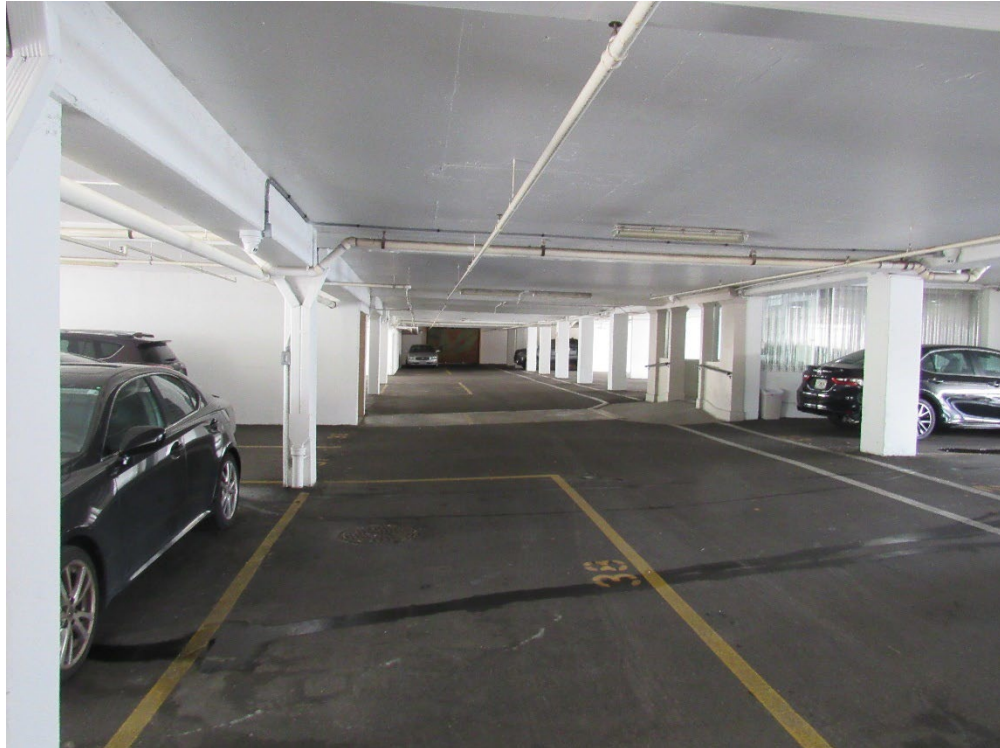
Partial view of garage.

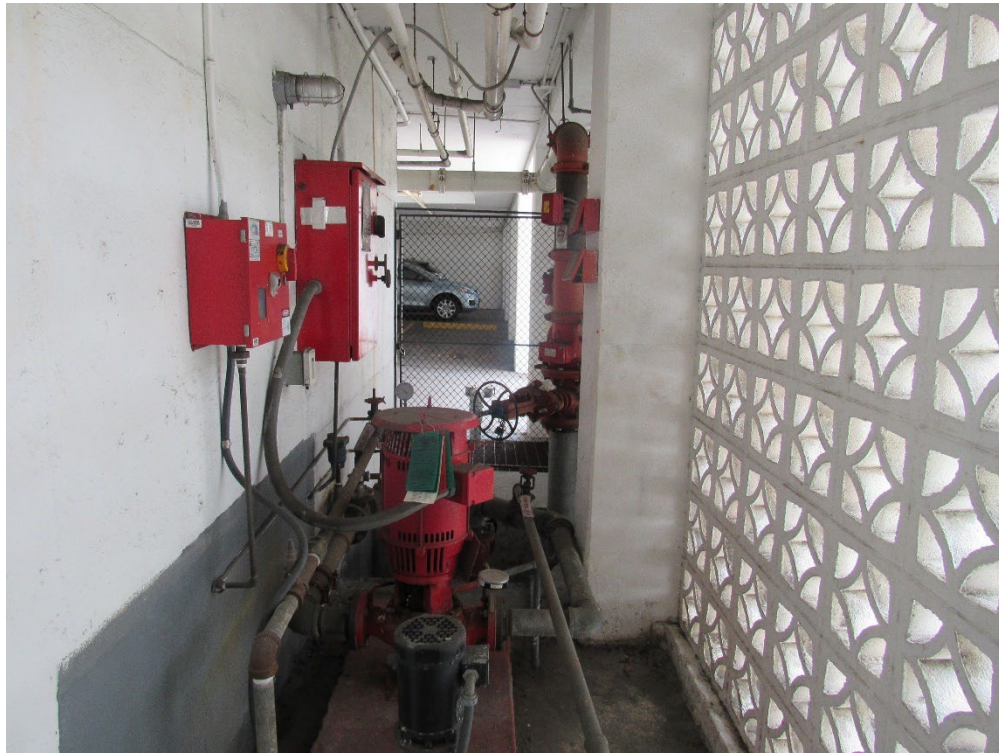
FACP and Audio-Visual Fire Alarm System and Sprinkler - The fire protection system includes a fire alarm control panel (FACP), fire pump, jockey pump, numerous audio-visual alarms, sprinkler system, fire alarm, and pull switches. The FACP is located on the ground floor near the elevator.

View of fire pump system.

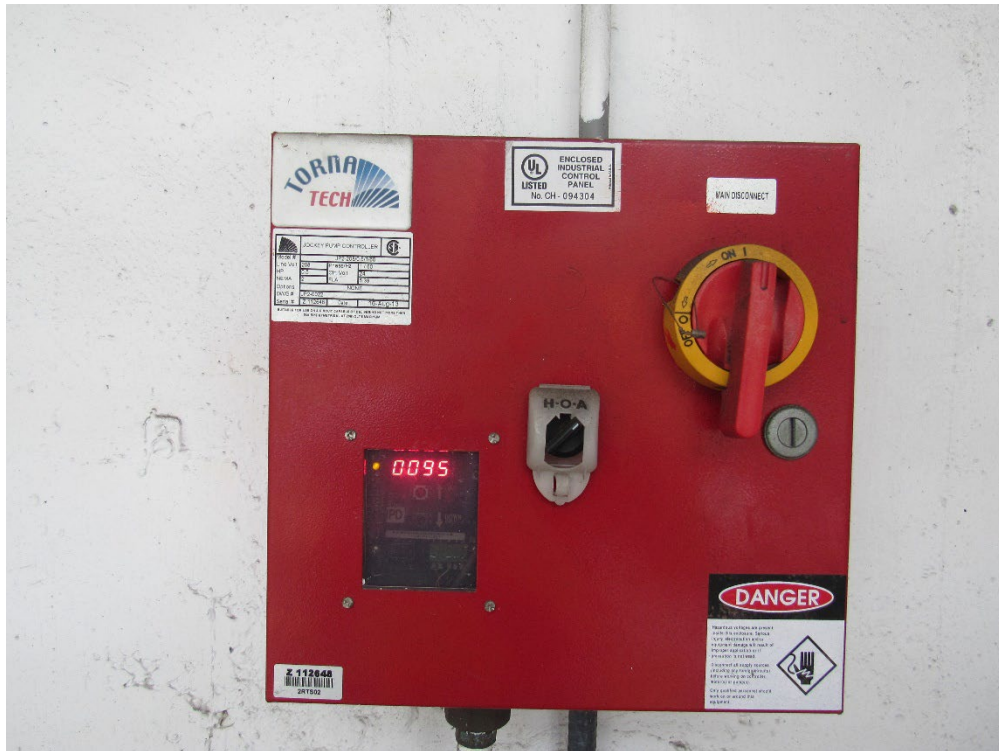
View of the jockey pump controller.

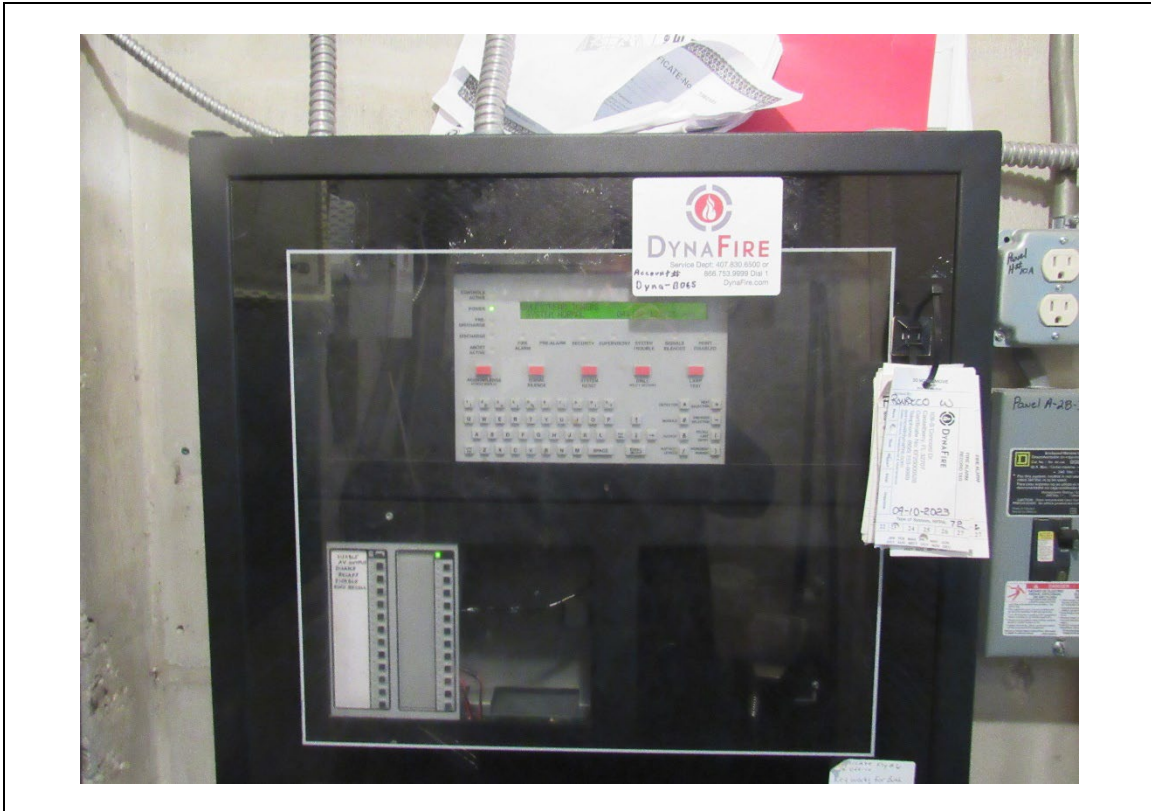
Numerous audio-visual alarms, fire extinguishers, and fire alarm pull switches are located throughout the building. Typically, these systems have a useful life of 30 years before requiring an updated system. We understand that the FACP and related components were replaced circa 2015.

View of the fire alarm control panel.

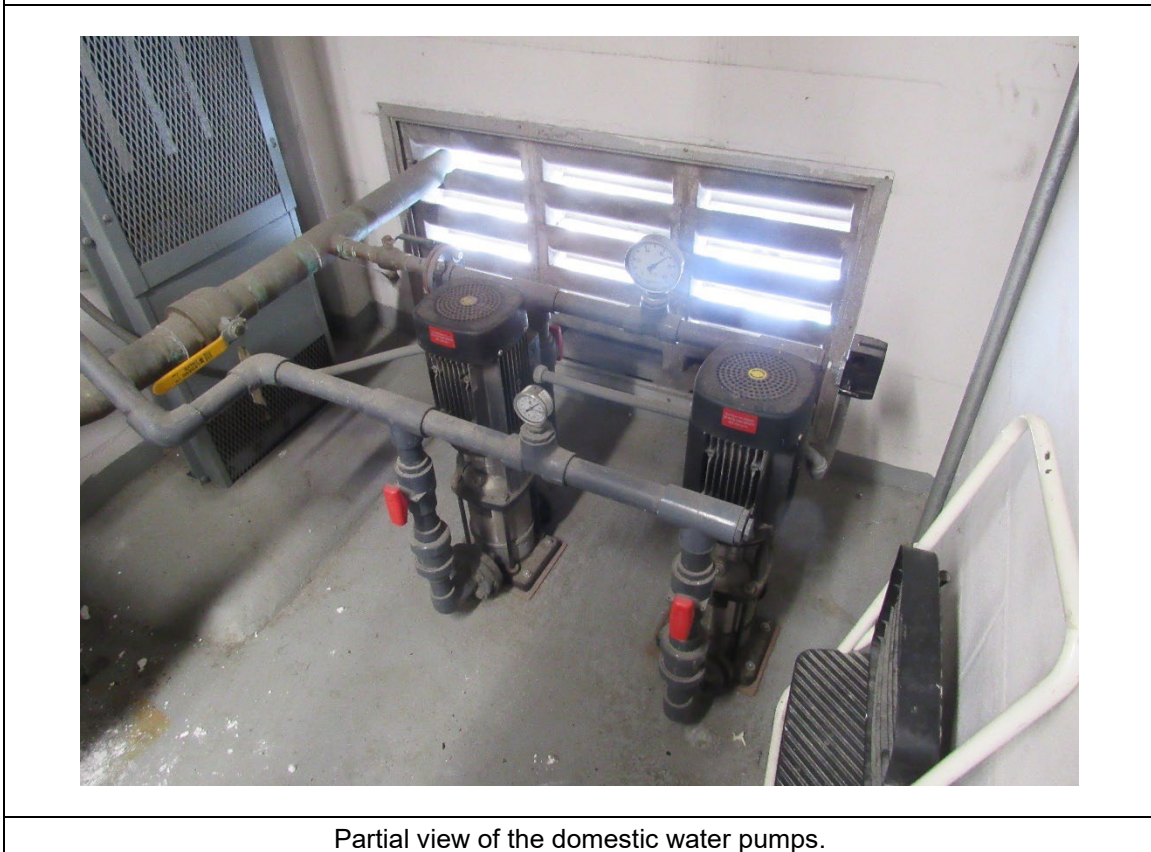
Domestic Water Pumps and Controls - We understand that the Association is responsible for the maintenance and replacement of the domestic water pumps and controller. In general, these items were observed to be in good overall condition. Typically, the domestic water pumps and controllers have a useful life of approximately 20 to 30 years. Therefore, we recommend replacing the current system circa 2040.

Partial view of the domestic water pumps.

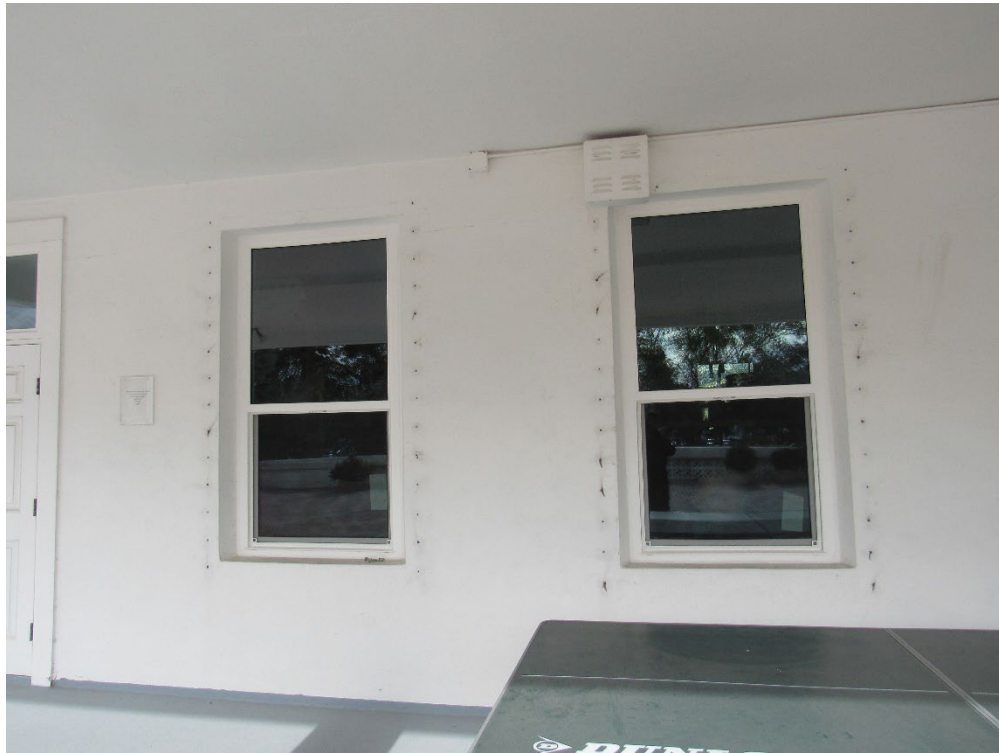
Common Area Windows - We understand the Association is responsible for all windows in the structure. The common area windows were installed circa 2023 and the unit windows are replaced on an as needed basis, both consist of aluminum framed windows. Typical windows of this type can achieve a useful life of 40 years. A reserve has been included for periodic replacement of the windows.

Typical view of the common area windows.

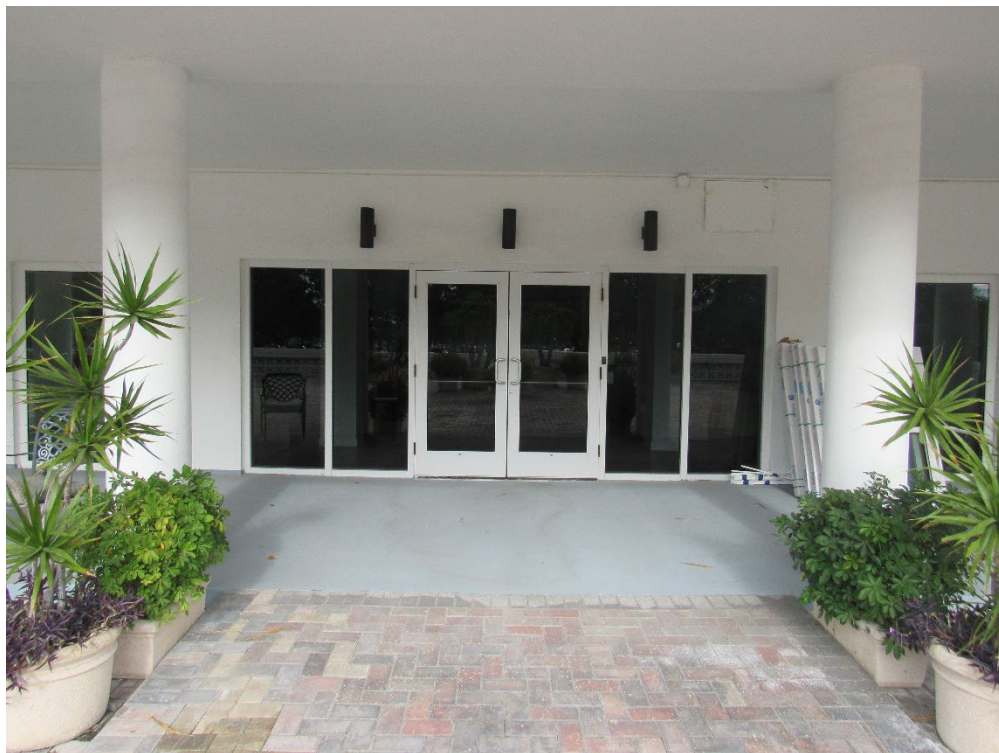
Common Exterior Doors - We understand the Association is responsible for all exterior doors in the structures. Replacement of the doors should vary based on routine maintenance, exposure, and wear and tear. We have included a reserve allowance for replacing the doors on an as needed basis.

Typical view of the common area windows and doors.
